# Navajo Abandoned Uranium Mine Site Screen Report

## **Foutz No. 1 AUM Site**

## **Navajo AUM Eastern Region**

**May 2009**

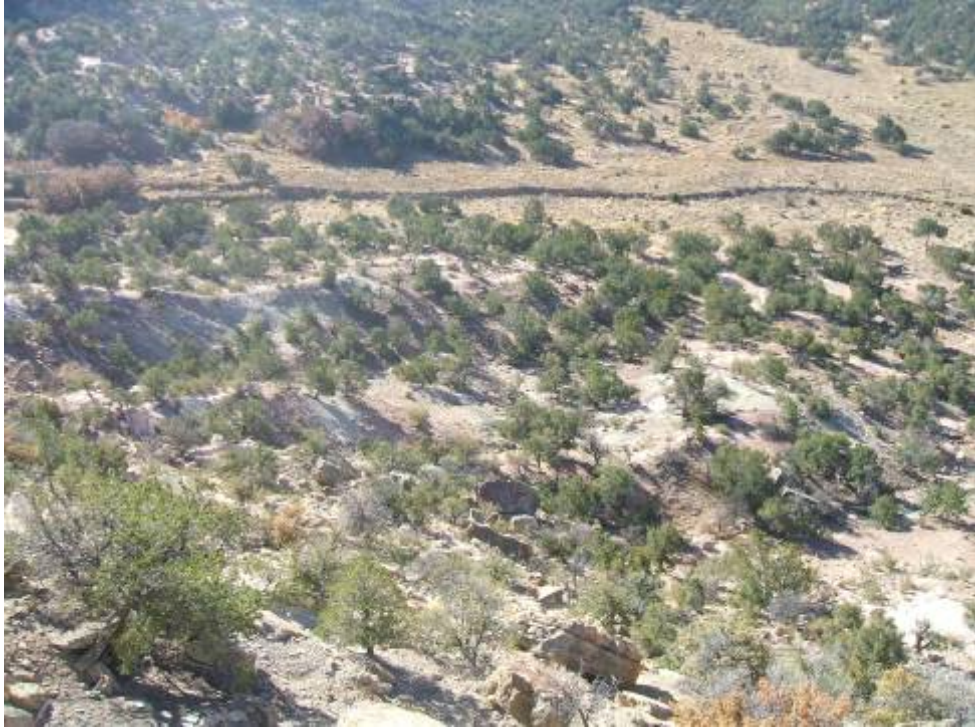
The site has been identified as reclaimed by the NAMLRP, with a reclaimed reference ID of NA-0550, and reclaimed status source of S06220502. No visual signs of reclamation were identified during the site visit. No waste piles, adits or other mine features were observed during the site visit.

Photo 1. Mine site, from top of cliff area, towards the southeast

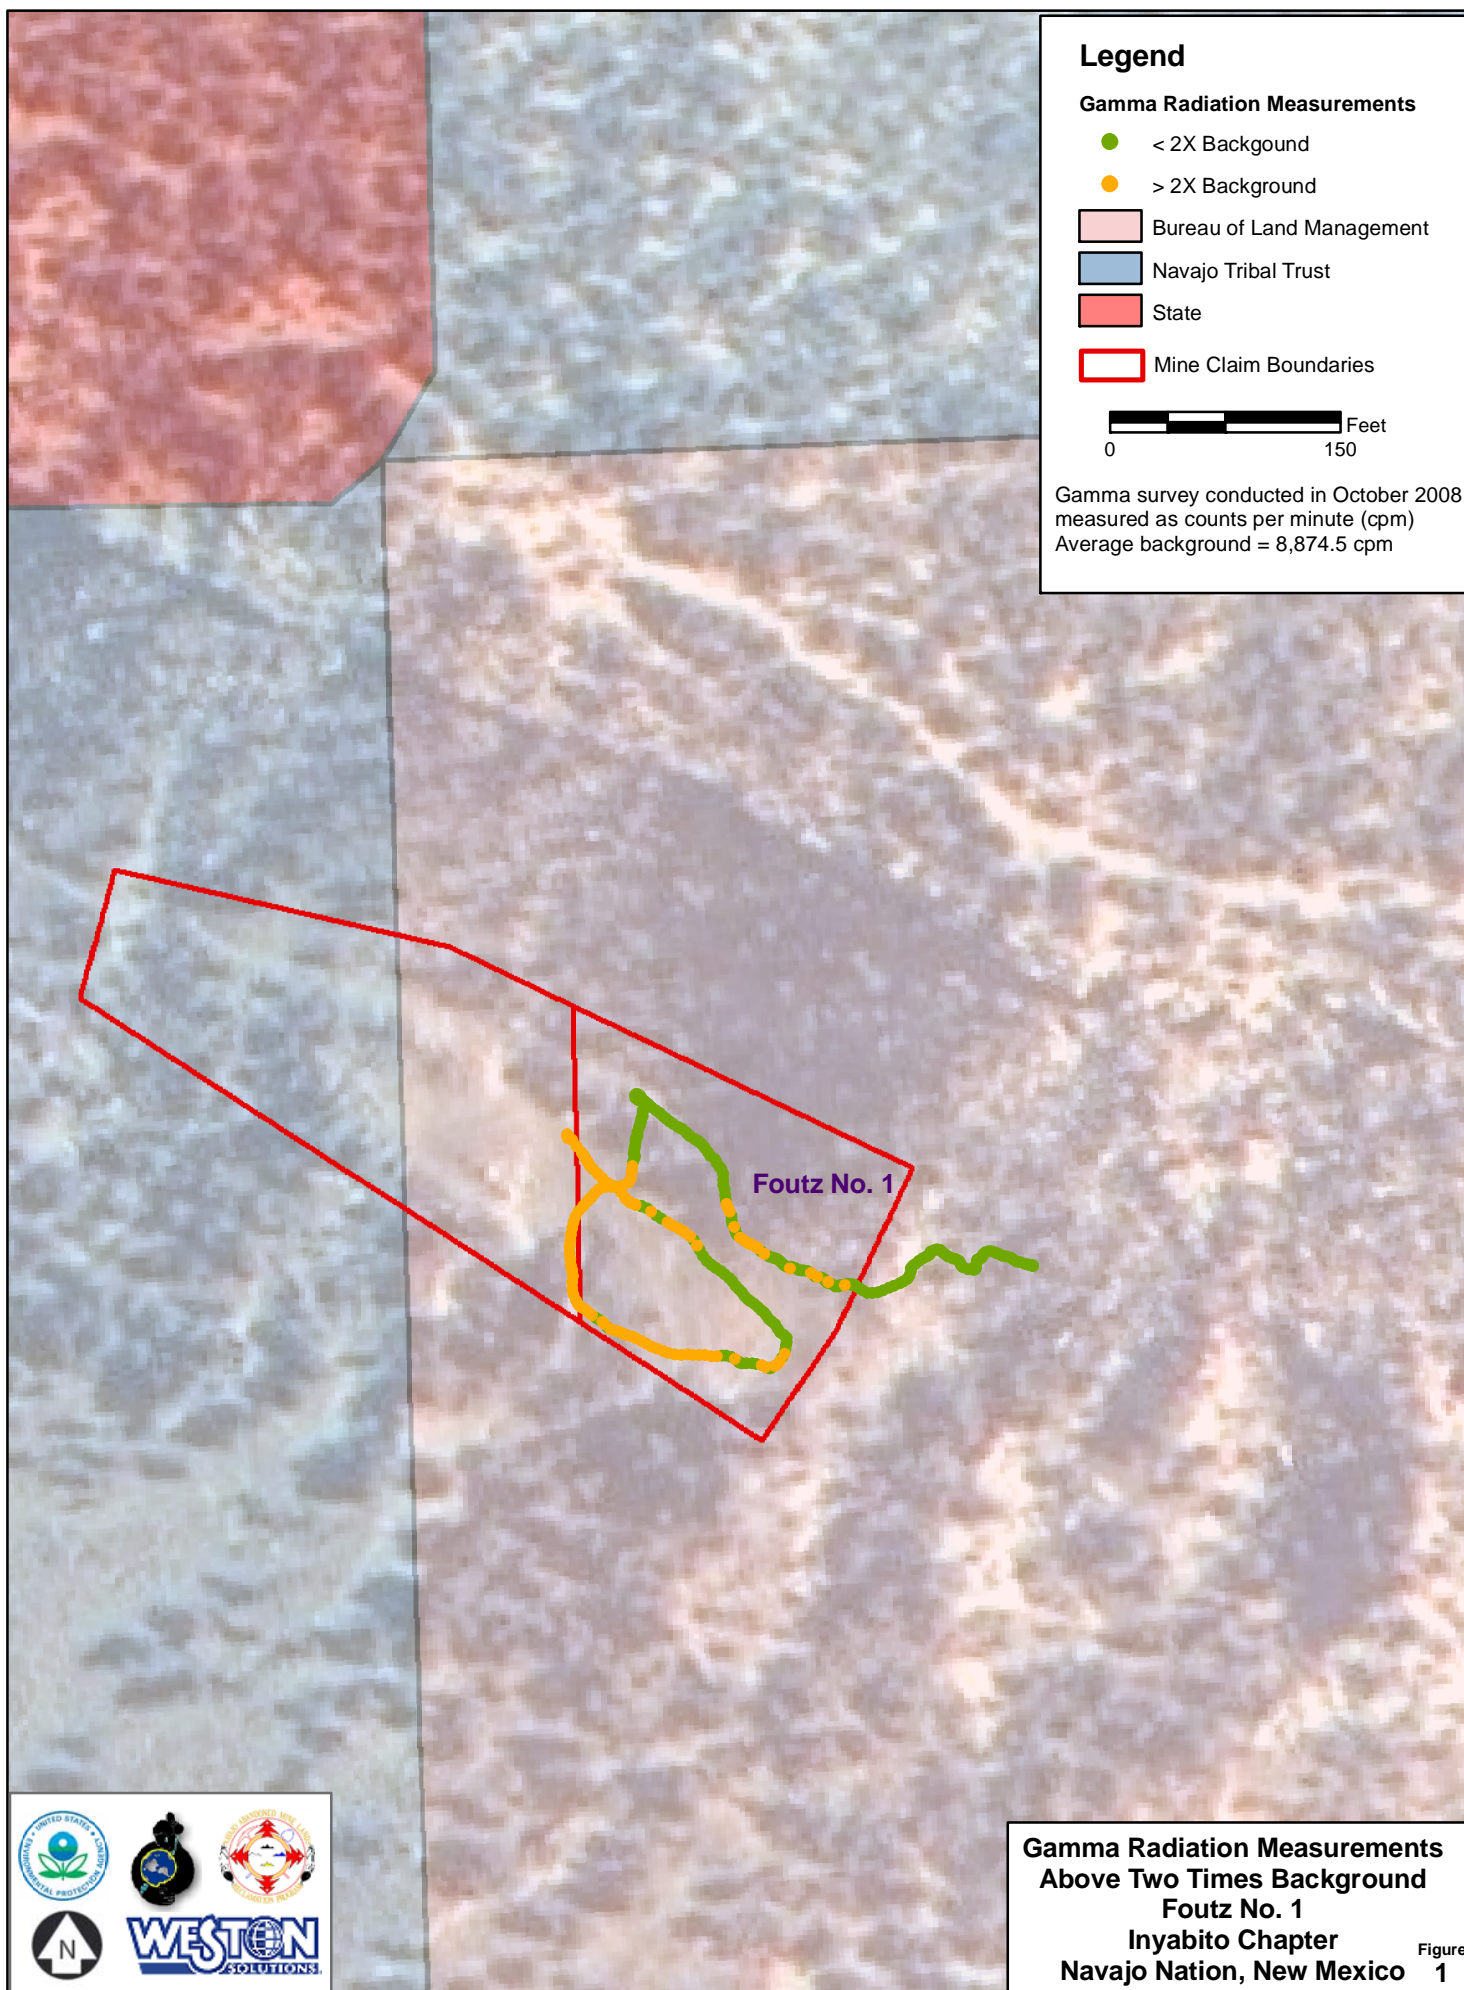
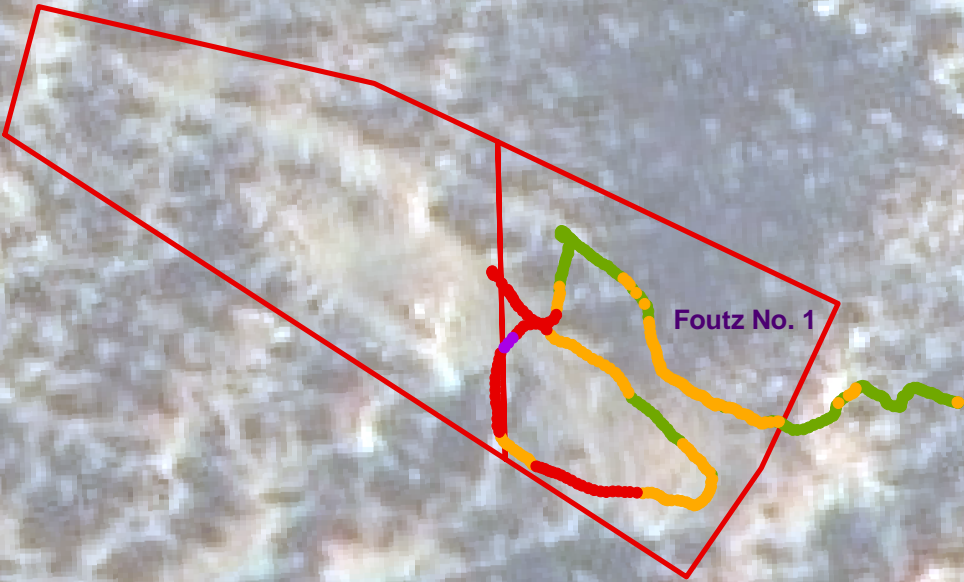
**Gamma Radiation Measurements**  
**Foutz No. 1**  
**Inyabito Chapter**  
**Navajo Nation, New Mexico**

A total of 343 gamma radiation measurements were collected from mine sites, ranging from 8,952 cpm to 54,311 cpm. The measurements are represented in Figures 1 and 2.

Gamma survey conducted in October 2008  
measured as counts per minute
